# Land At Englishcombe Lane Bath

## Revised Site Plan

Public Exhibition Event  
January 2018

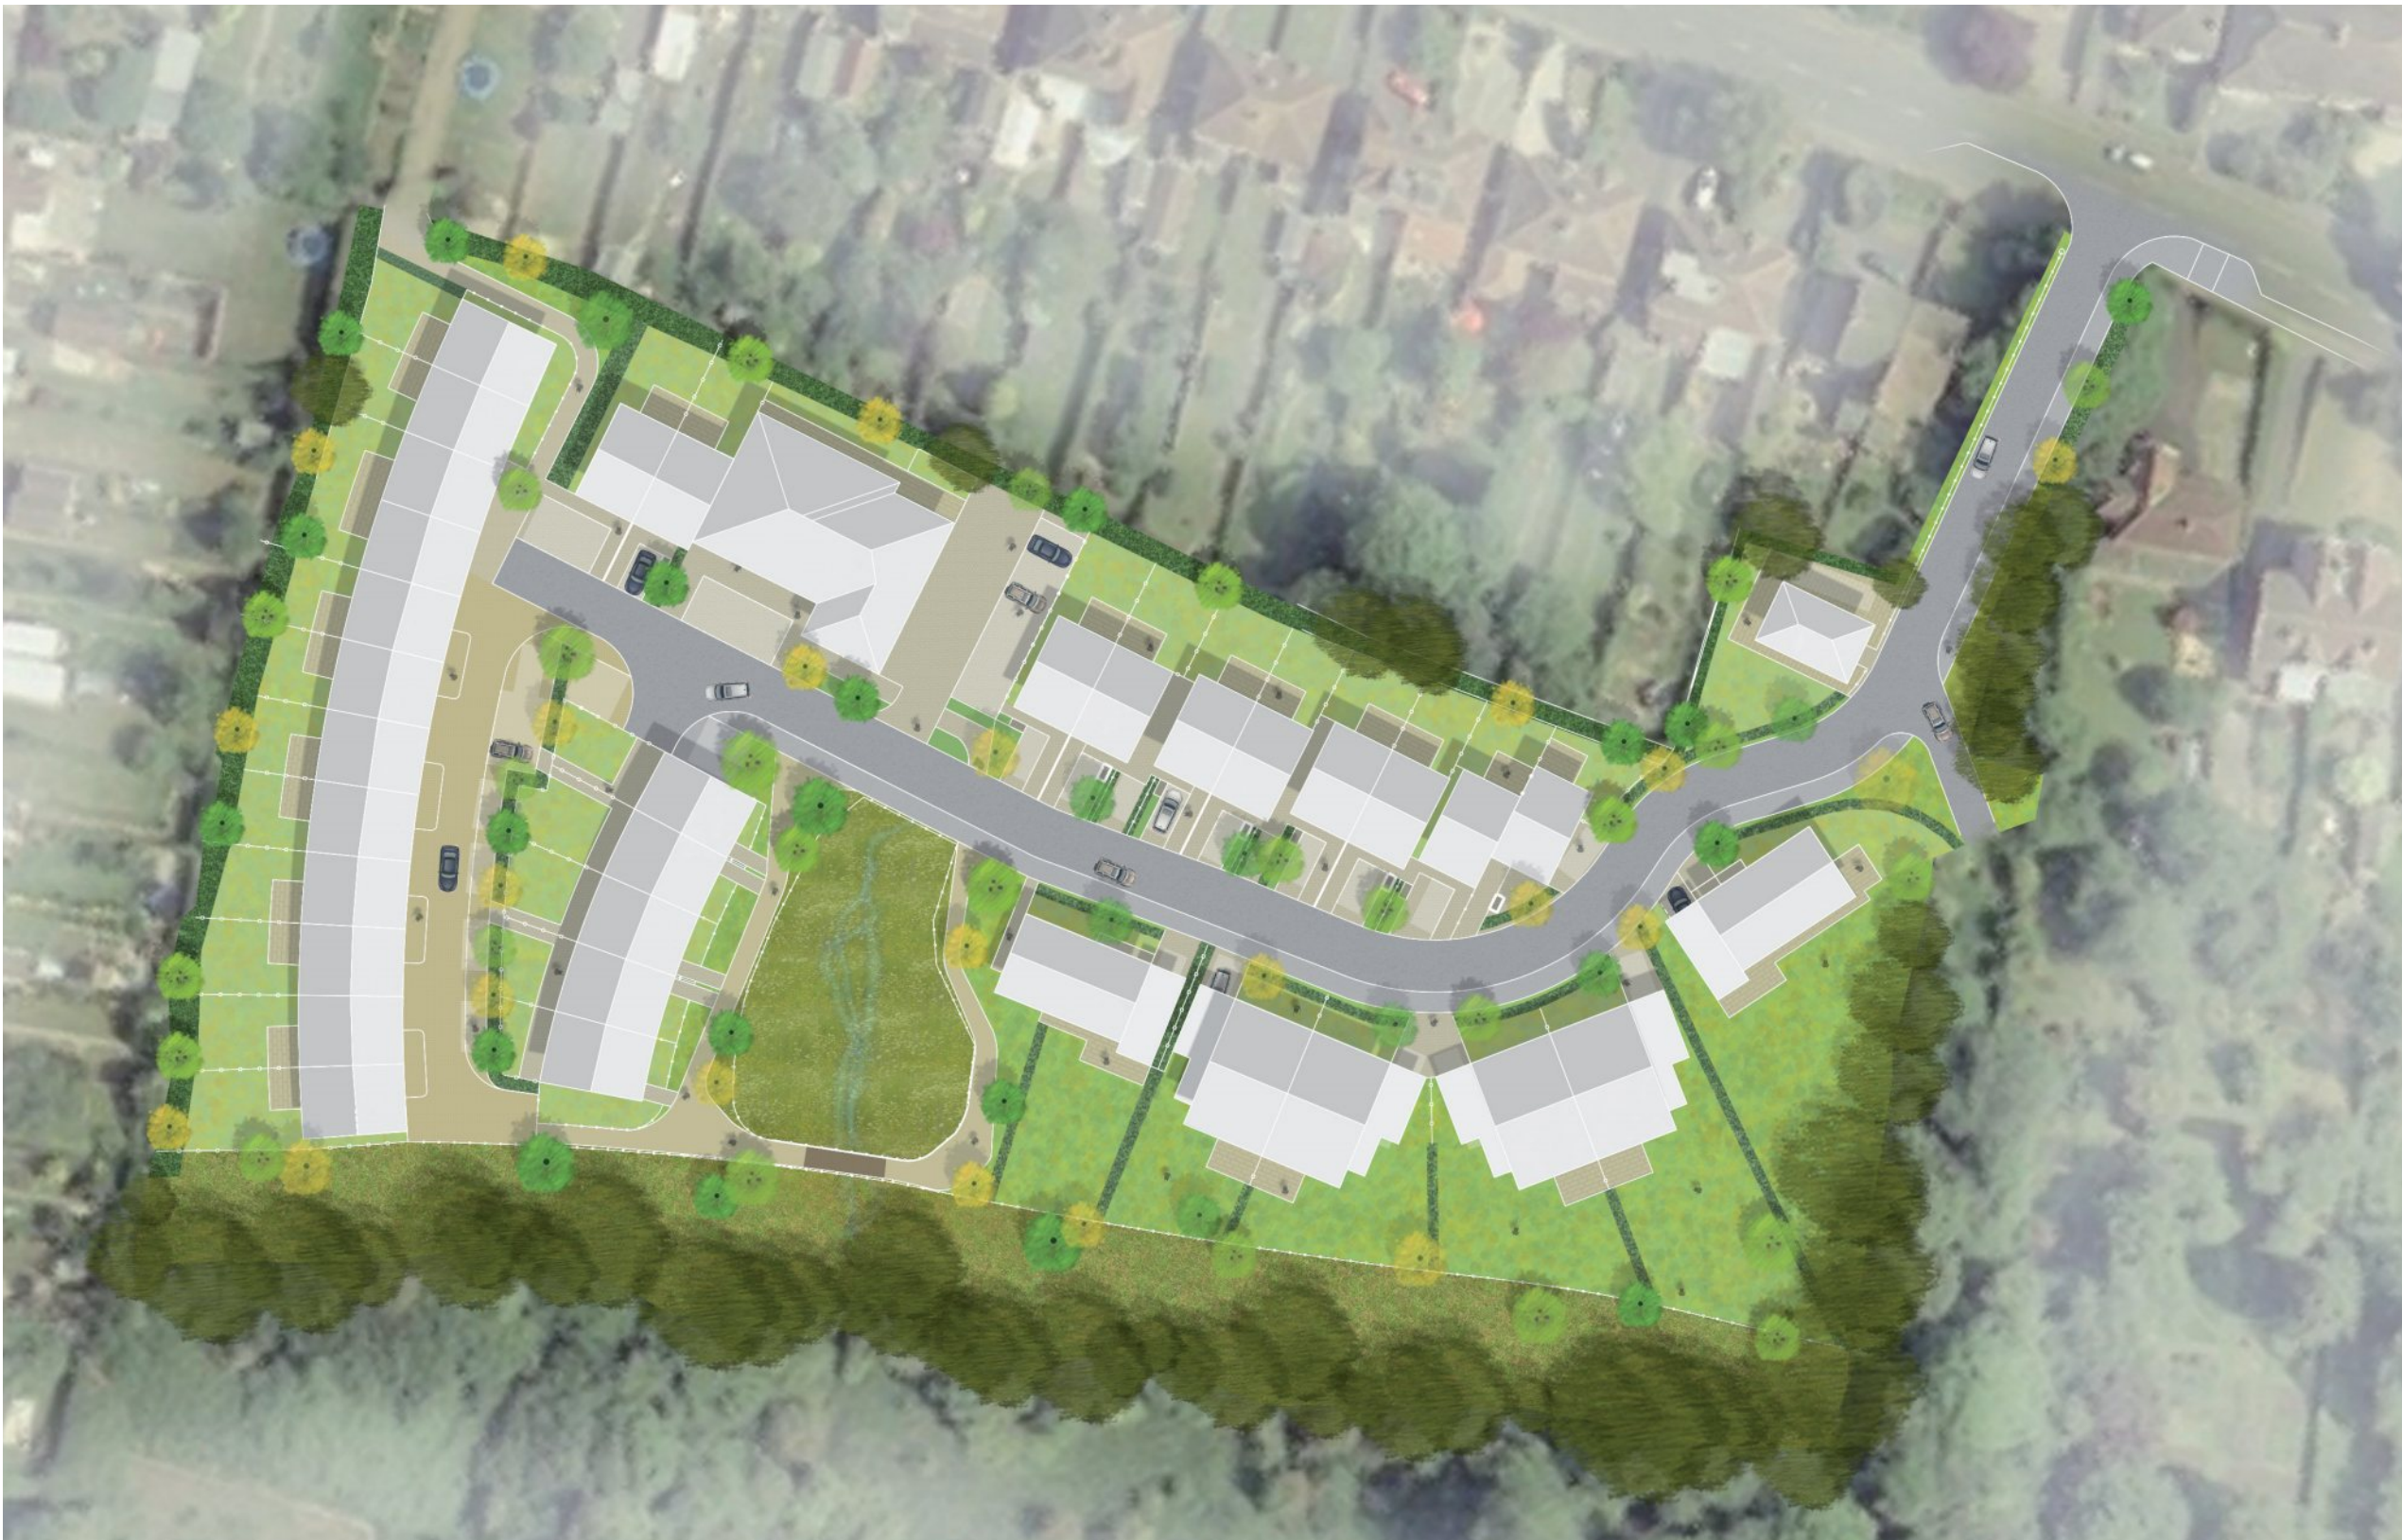
PREVIOUS CONSULTATION SITE PLAN - 12TH JULY 2017

### POINTS RAISED AT PREVIOUS PUBLIC CONSULTATION:

- 1. Density considered too high.
- 2. Crescent contained too many houses.
- 3. The houses backing onto Englishcombe Lane were too close in proximity to the boundary.
- 4. Concerns that the level difference would encourage overlooking gardens.
- 5. The position of the potential flats backing onto gardens was considered a security and privacy issue.
- 6. Not enough parking on site for the number of units.

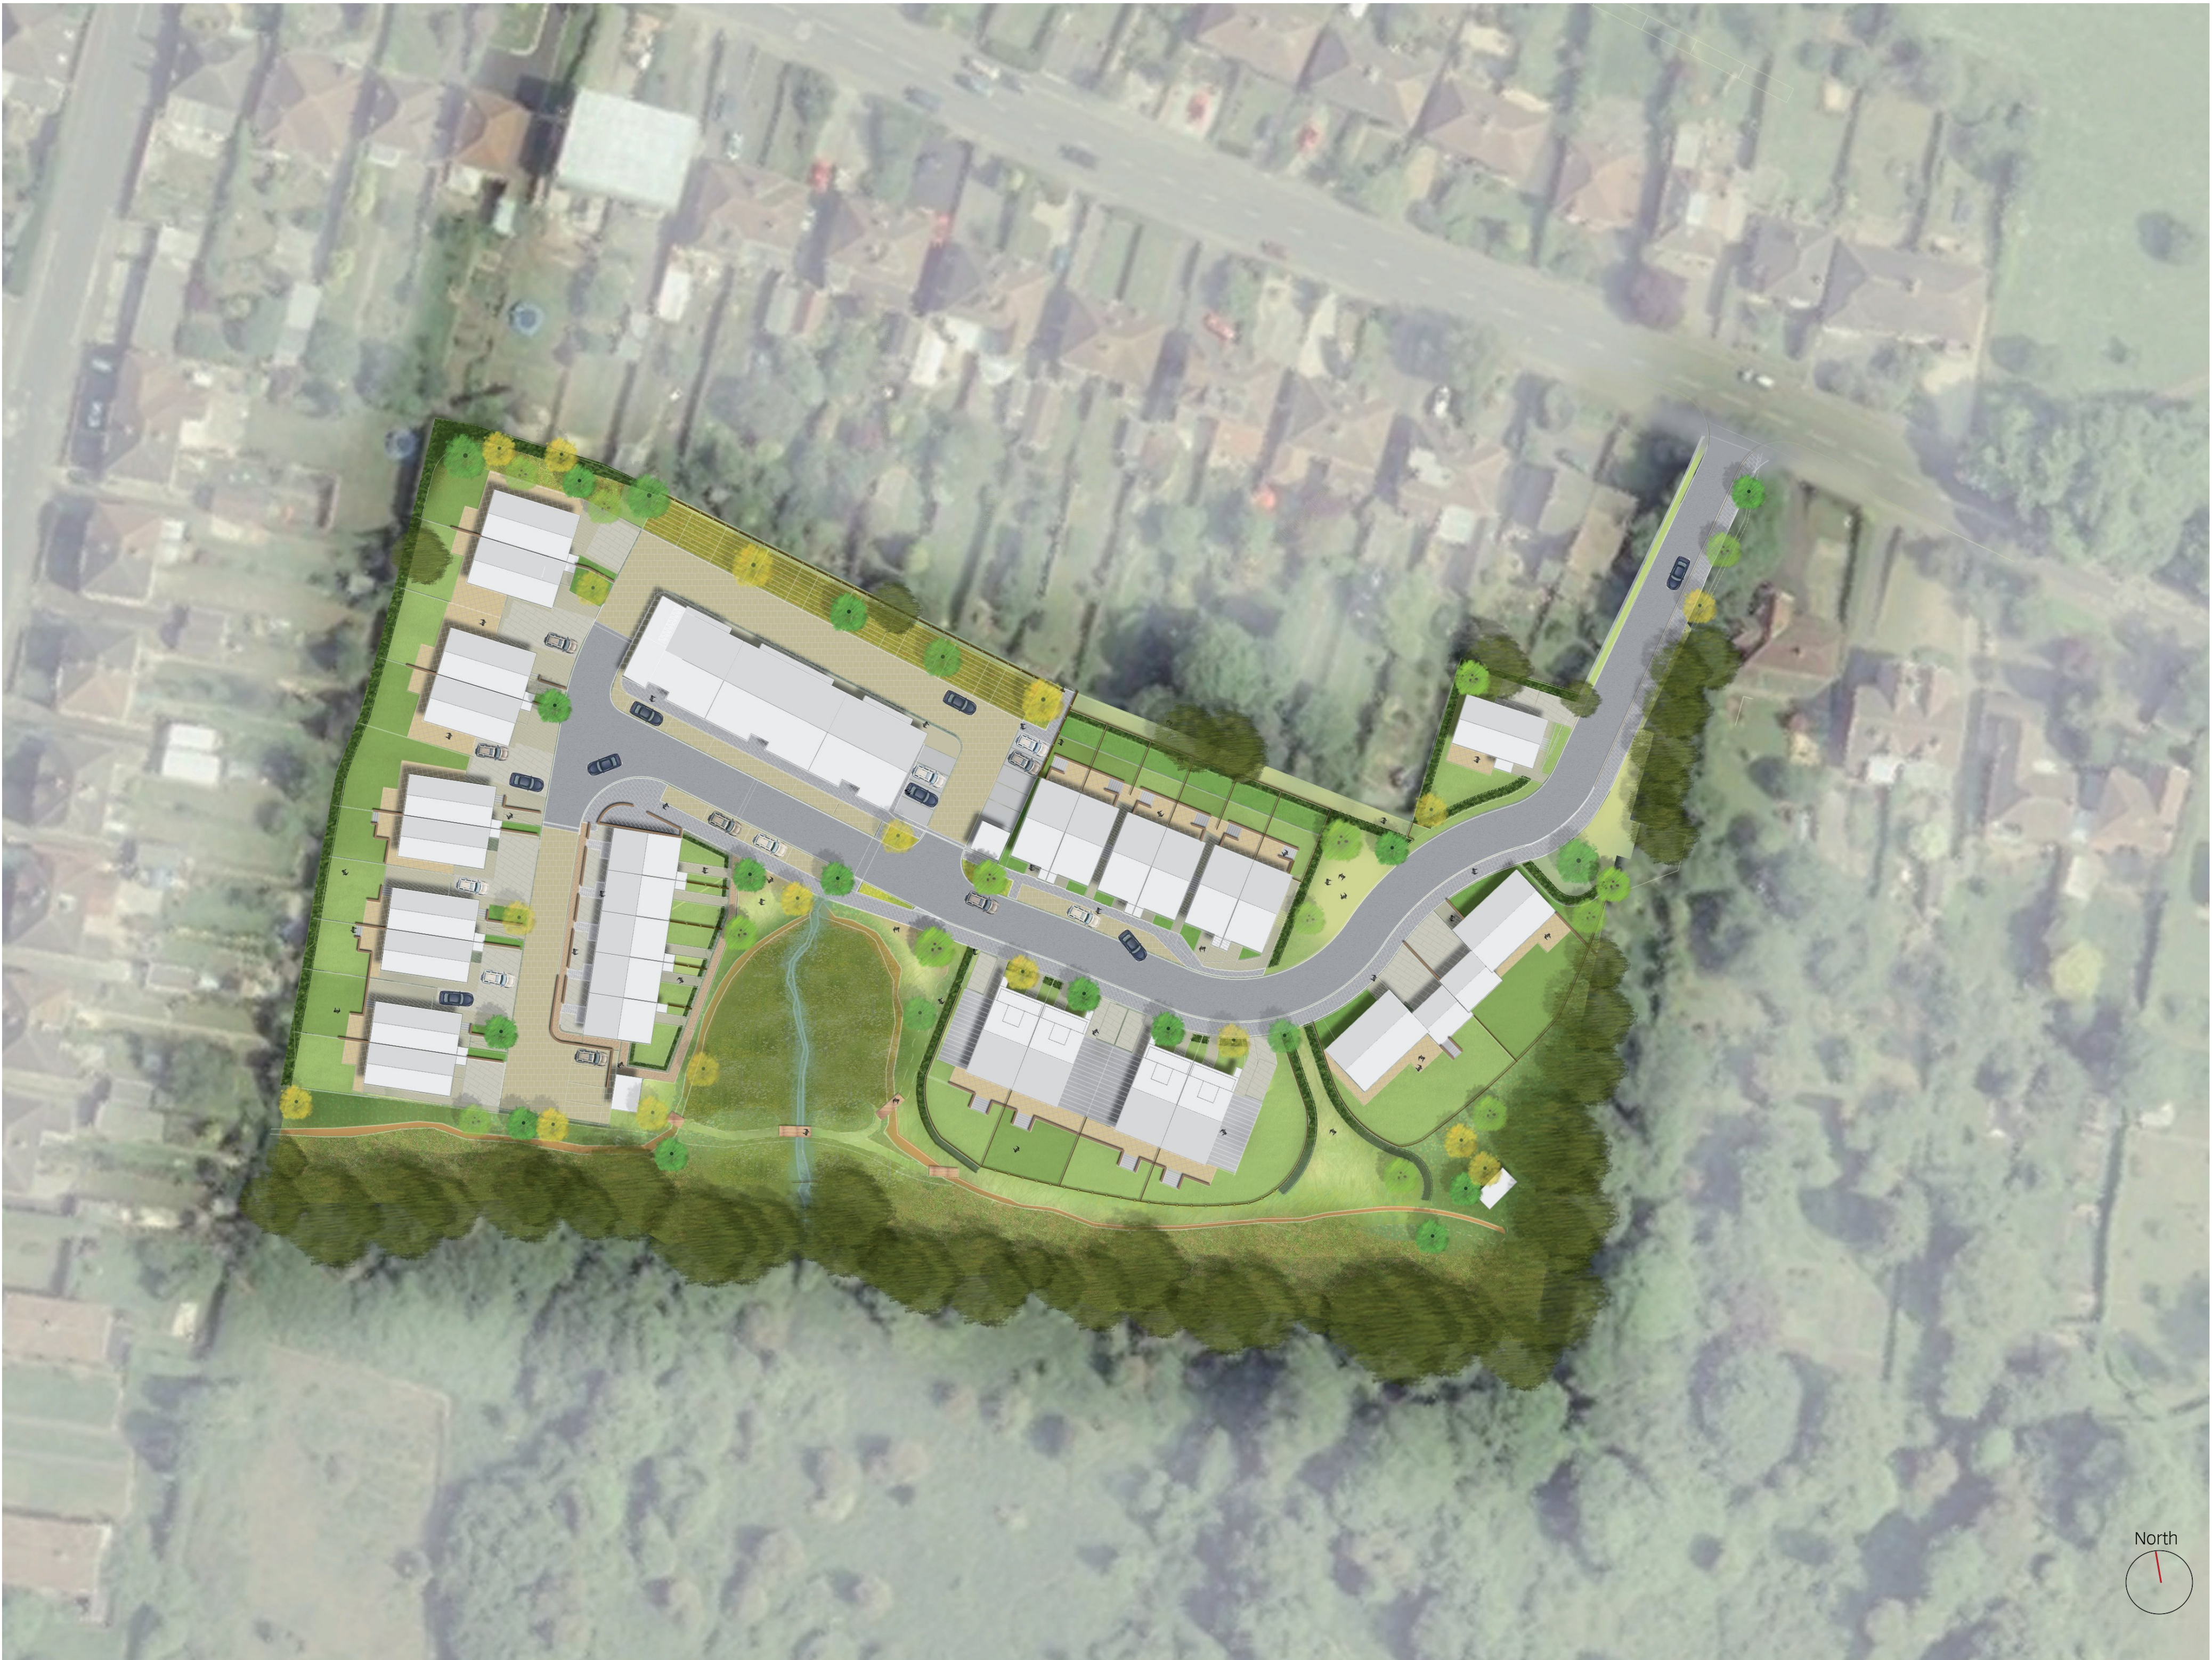
PROPOSED SITE PLAN

### RESPONSE:

- 1. Density has been reduced from 43 units to 38 units.
- 2. The crescent has been replaced with semi detached residential units.
- 3. 30 percent affordable housing on site.
- 4. The houses backing onto Englishcombe Lane have moved away from the boundary and a landscape buffer zone introduced.
- 5. The flats backing onto Englishcombe lane have been relocated to introduce a buffer zone between the dwellings and the boundary.
- 6. Parking levels have been increased to 89 parking spaces for residents and visitors use in accordance with the regulatory policy.

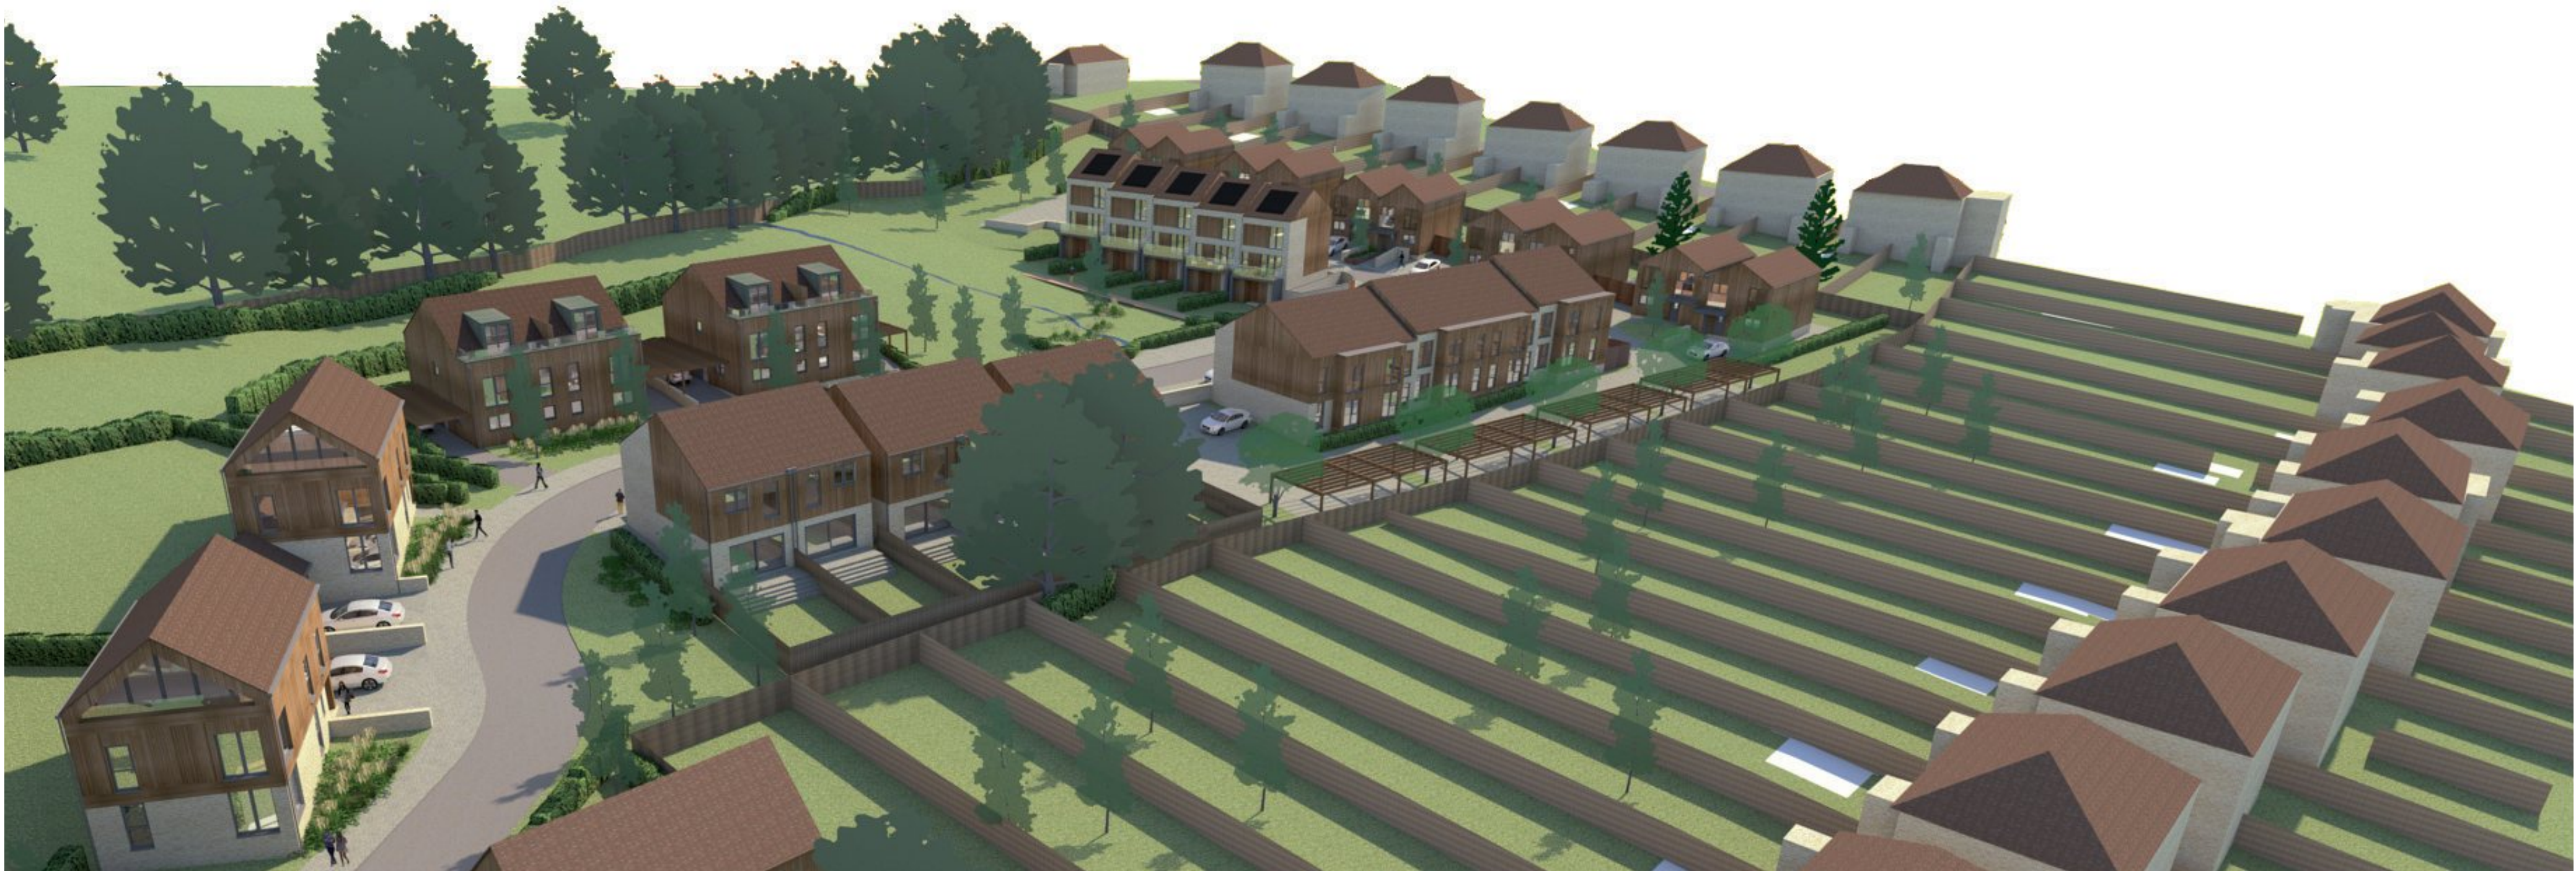
AERIAL VIEW LOOKING SOUTH WEST ACROSS THE SITE

- 1. Through detailed distant view analysis of massing and ridge lines all three storey units along the western boundary have been reduced to two storey.
- 2. The material palette has been chosen to reflect the local vernacular consisting of buff brick and timber cladding. Roof materials have been chosen to be weathered rustic red clay tiles similar to surrounding properties, blending the development into long distant views.
- 3. Roofscapes follow the topography and urban grain of Englishcombe Lane and Stirlingale Road.

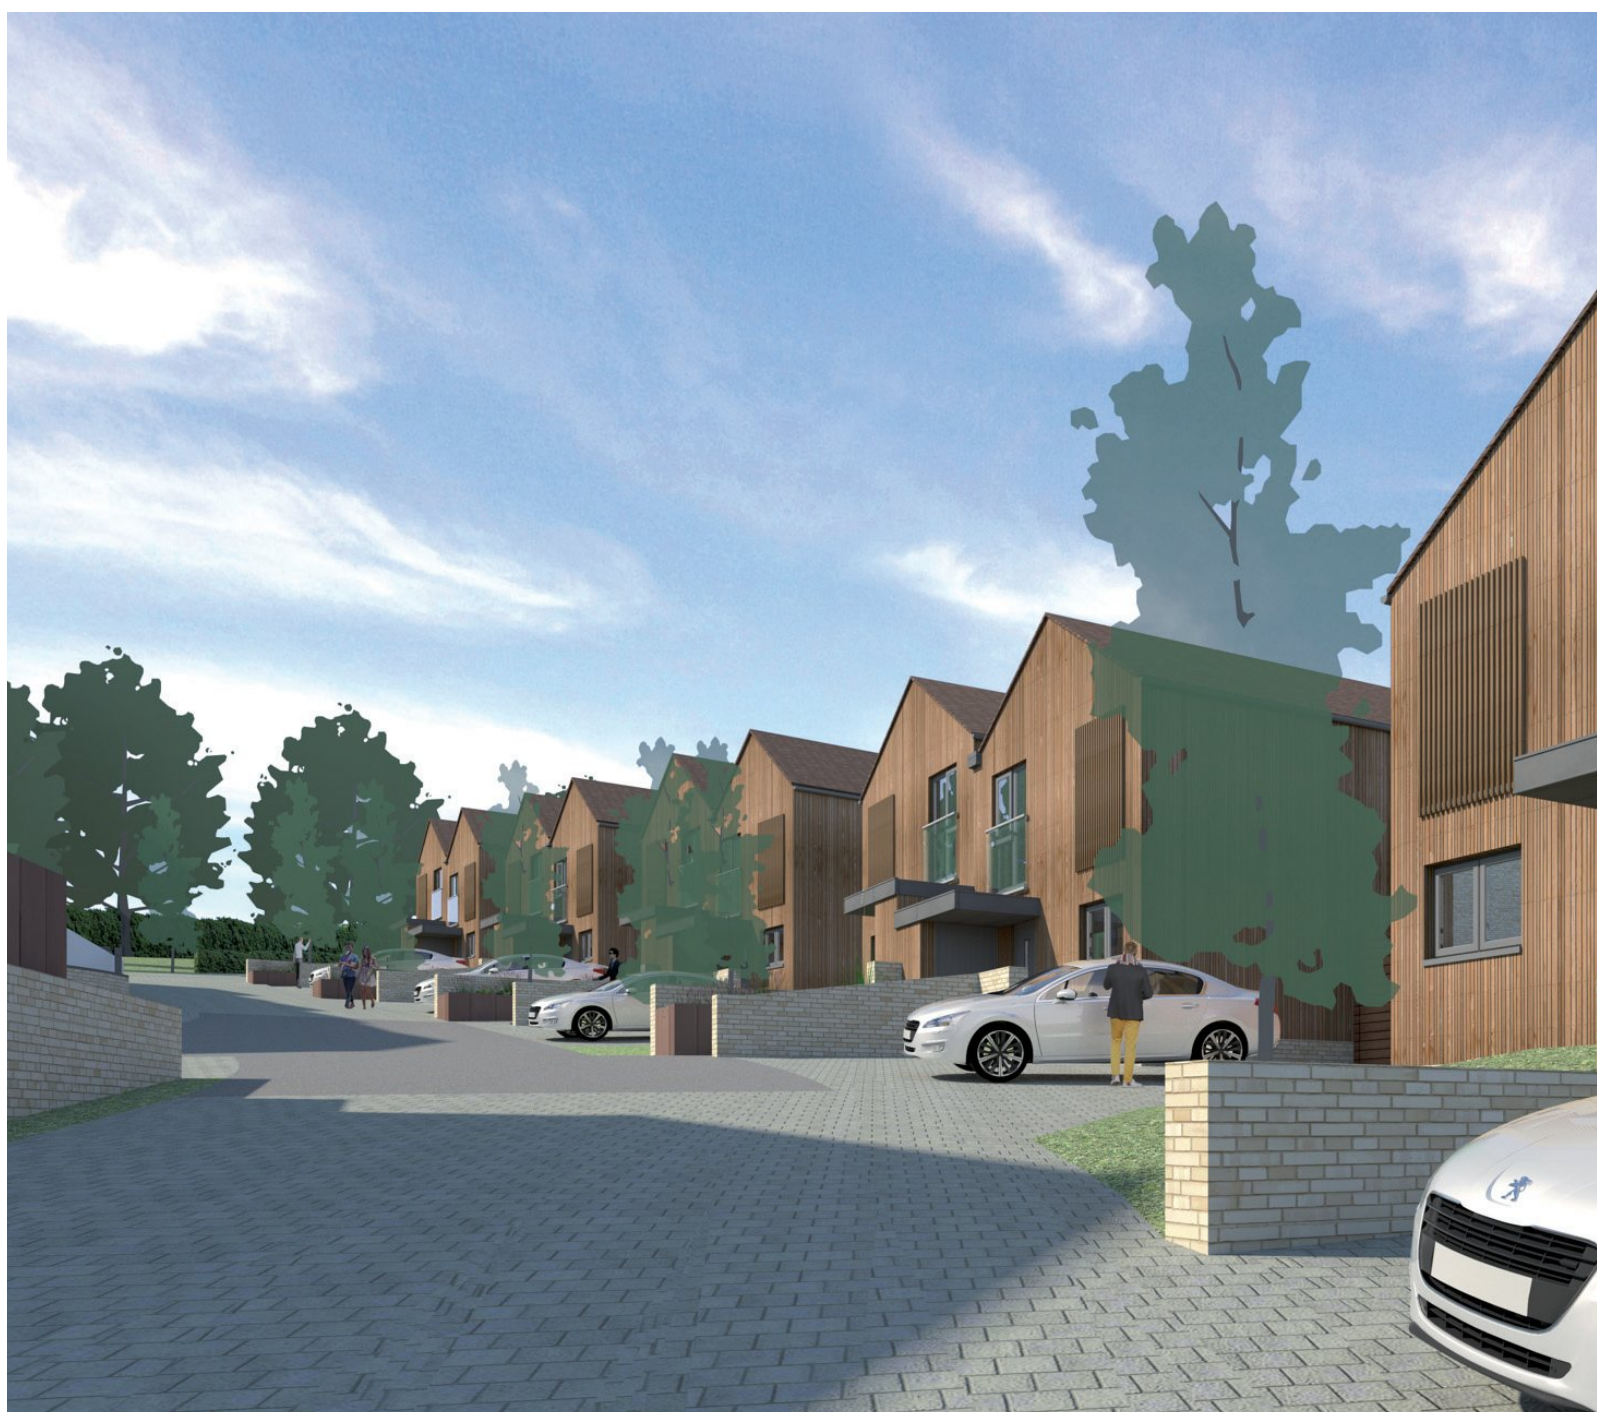
01 - WESTERN BOUNDARY 2 STOREY, 2 AND 3 BEDROOM HOUSES

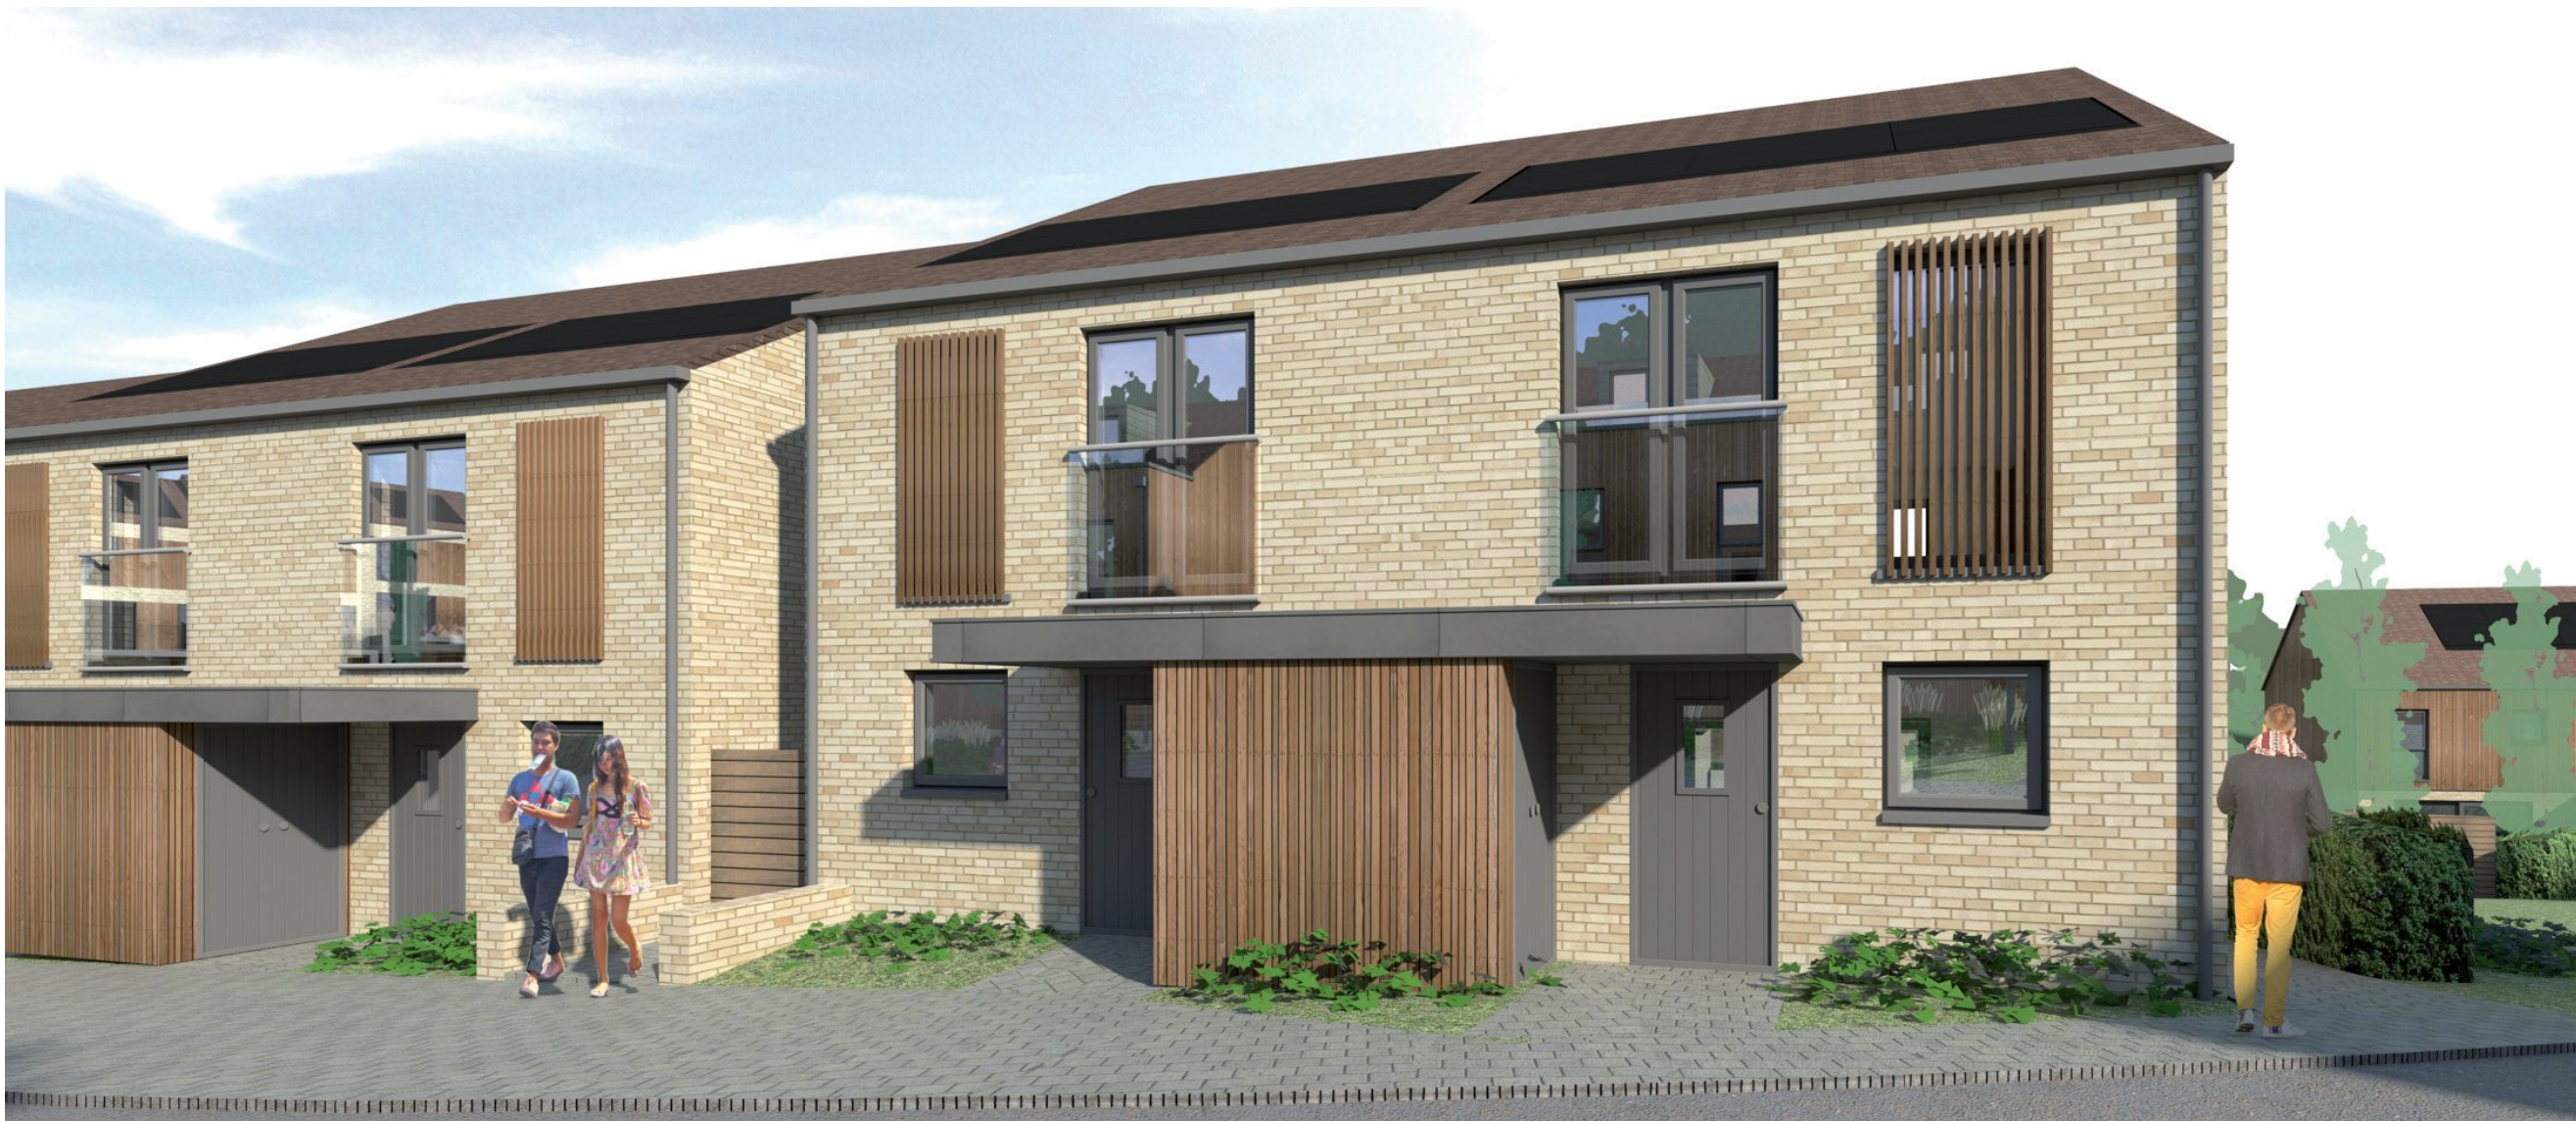
03 - LOOKING NORTH WITHIN THE SITE TOWARDS THE SPLIT LEVEL 2 BEDROOM HOUSES

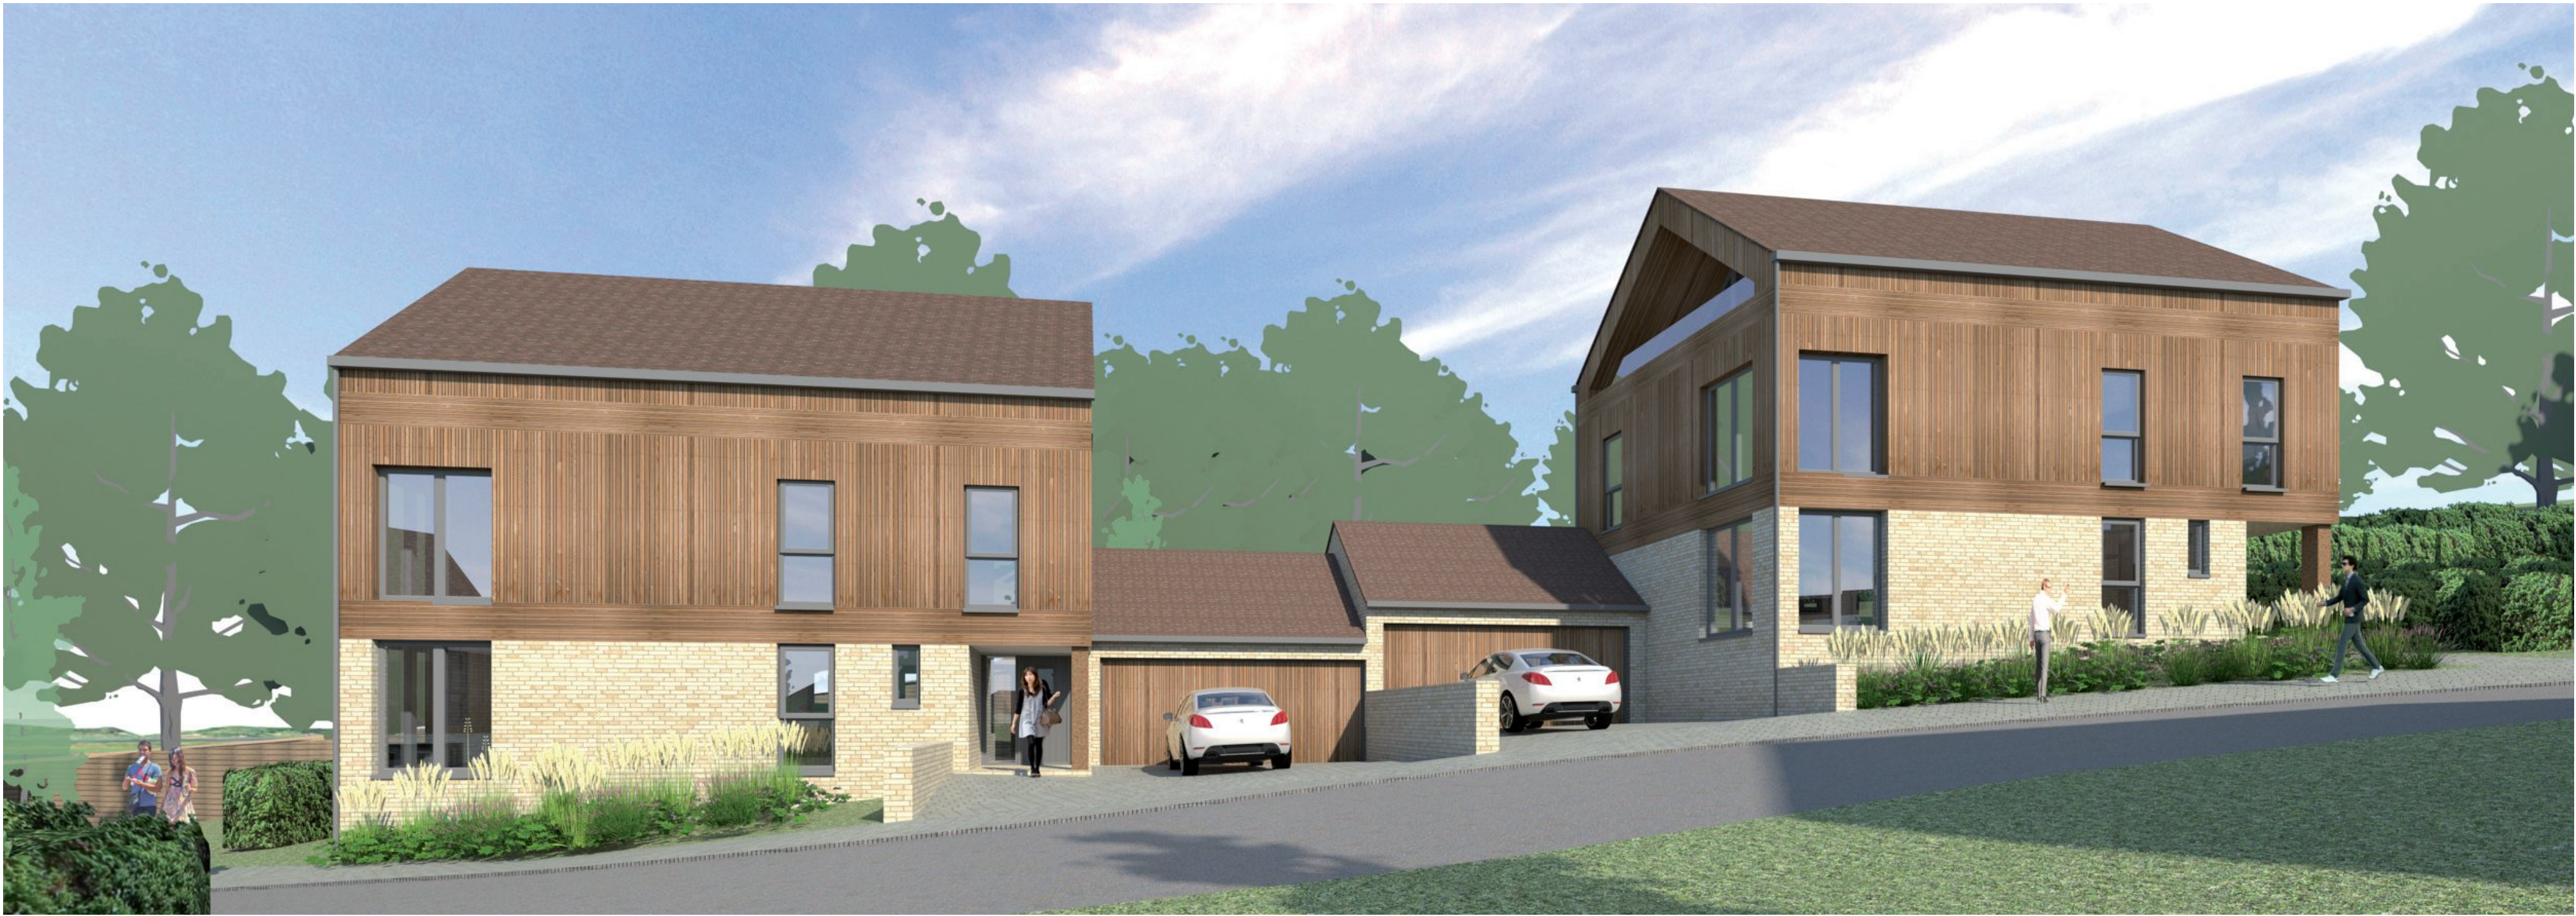
04 - EASTERN BOUNDARY 4 BEDROOM HOUSES

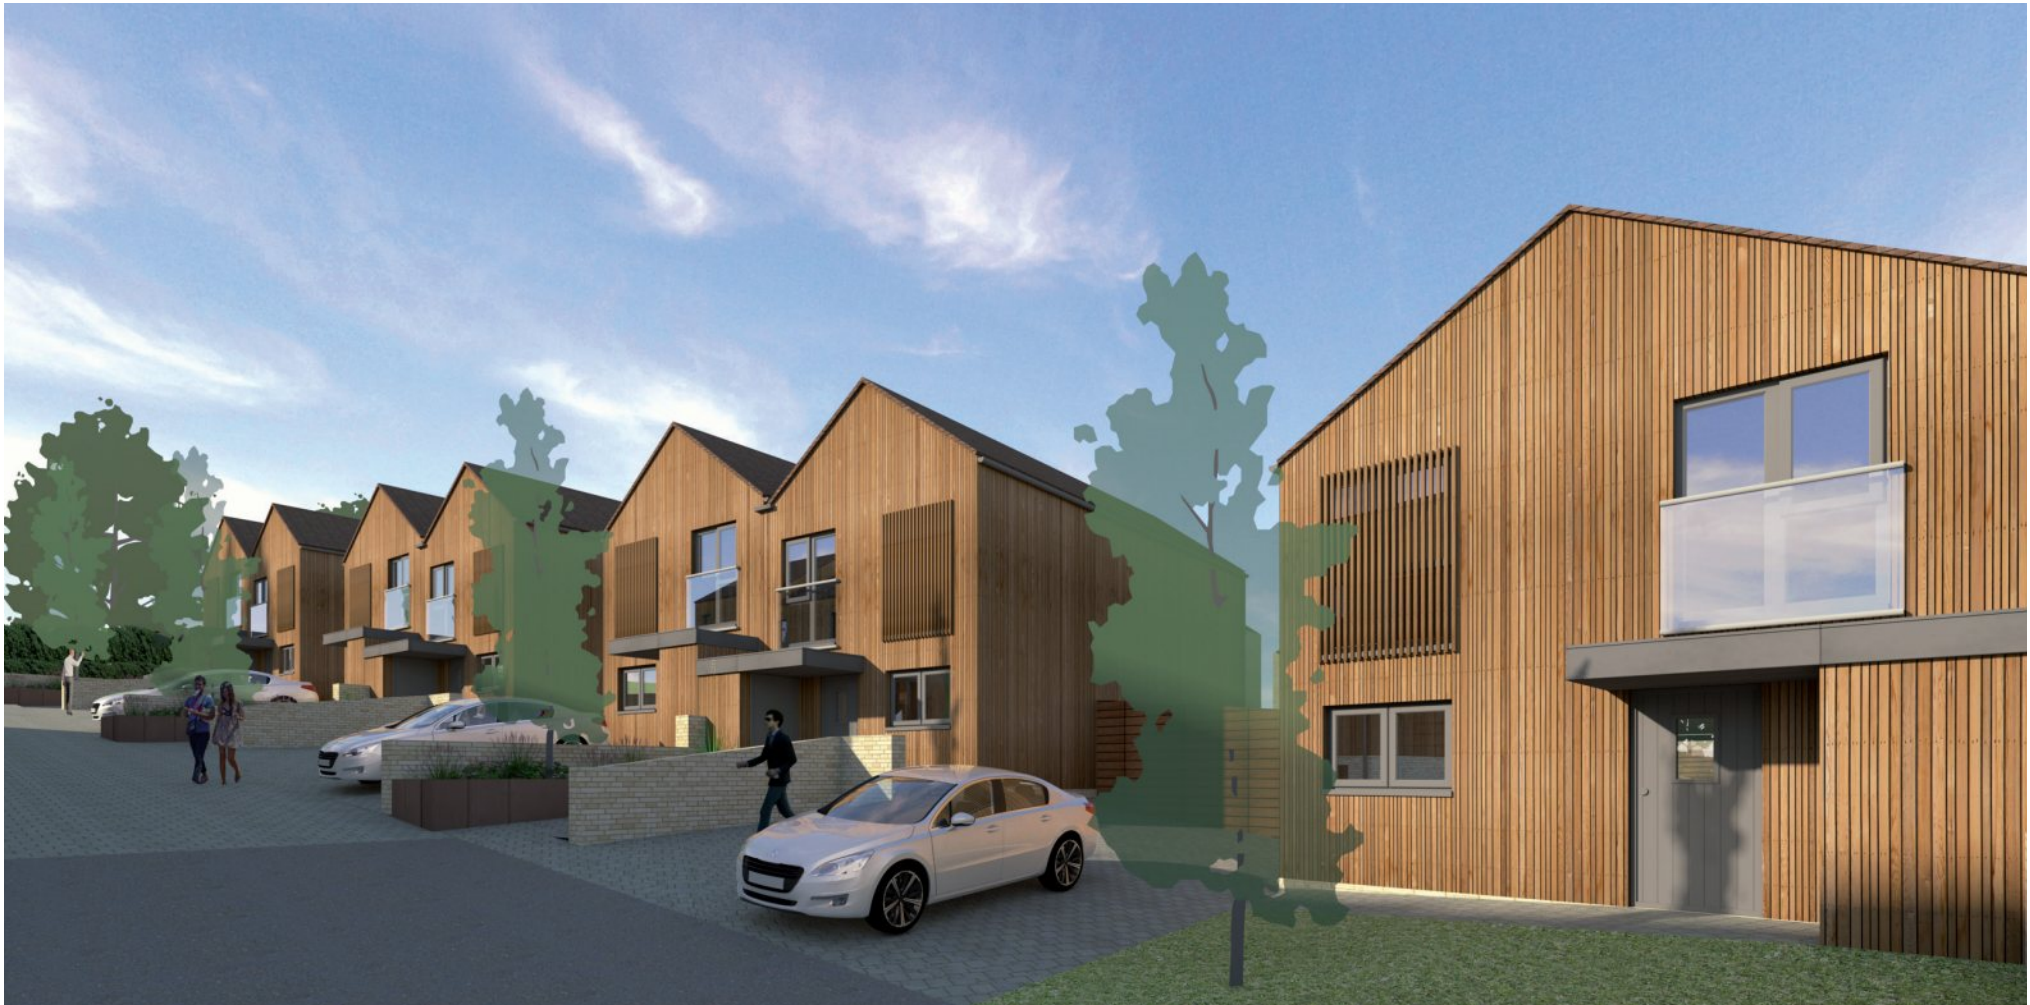
08 - WESTERN BOUNDARY 2 STOREY, 2 AND 3 BEDROOM HOUSES
