# Land At Englishcombe Lane Bath

## Revised Site Plan

Public Exhibition Event  
January 2018

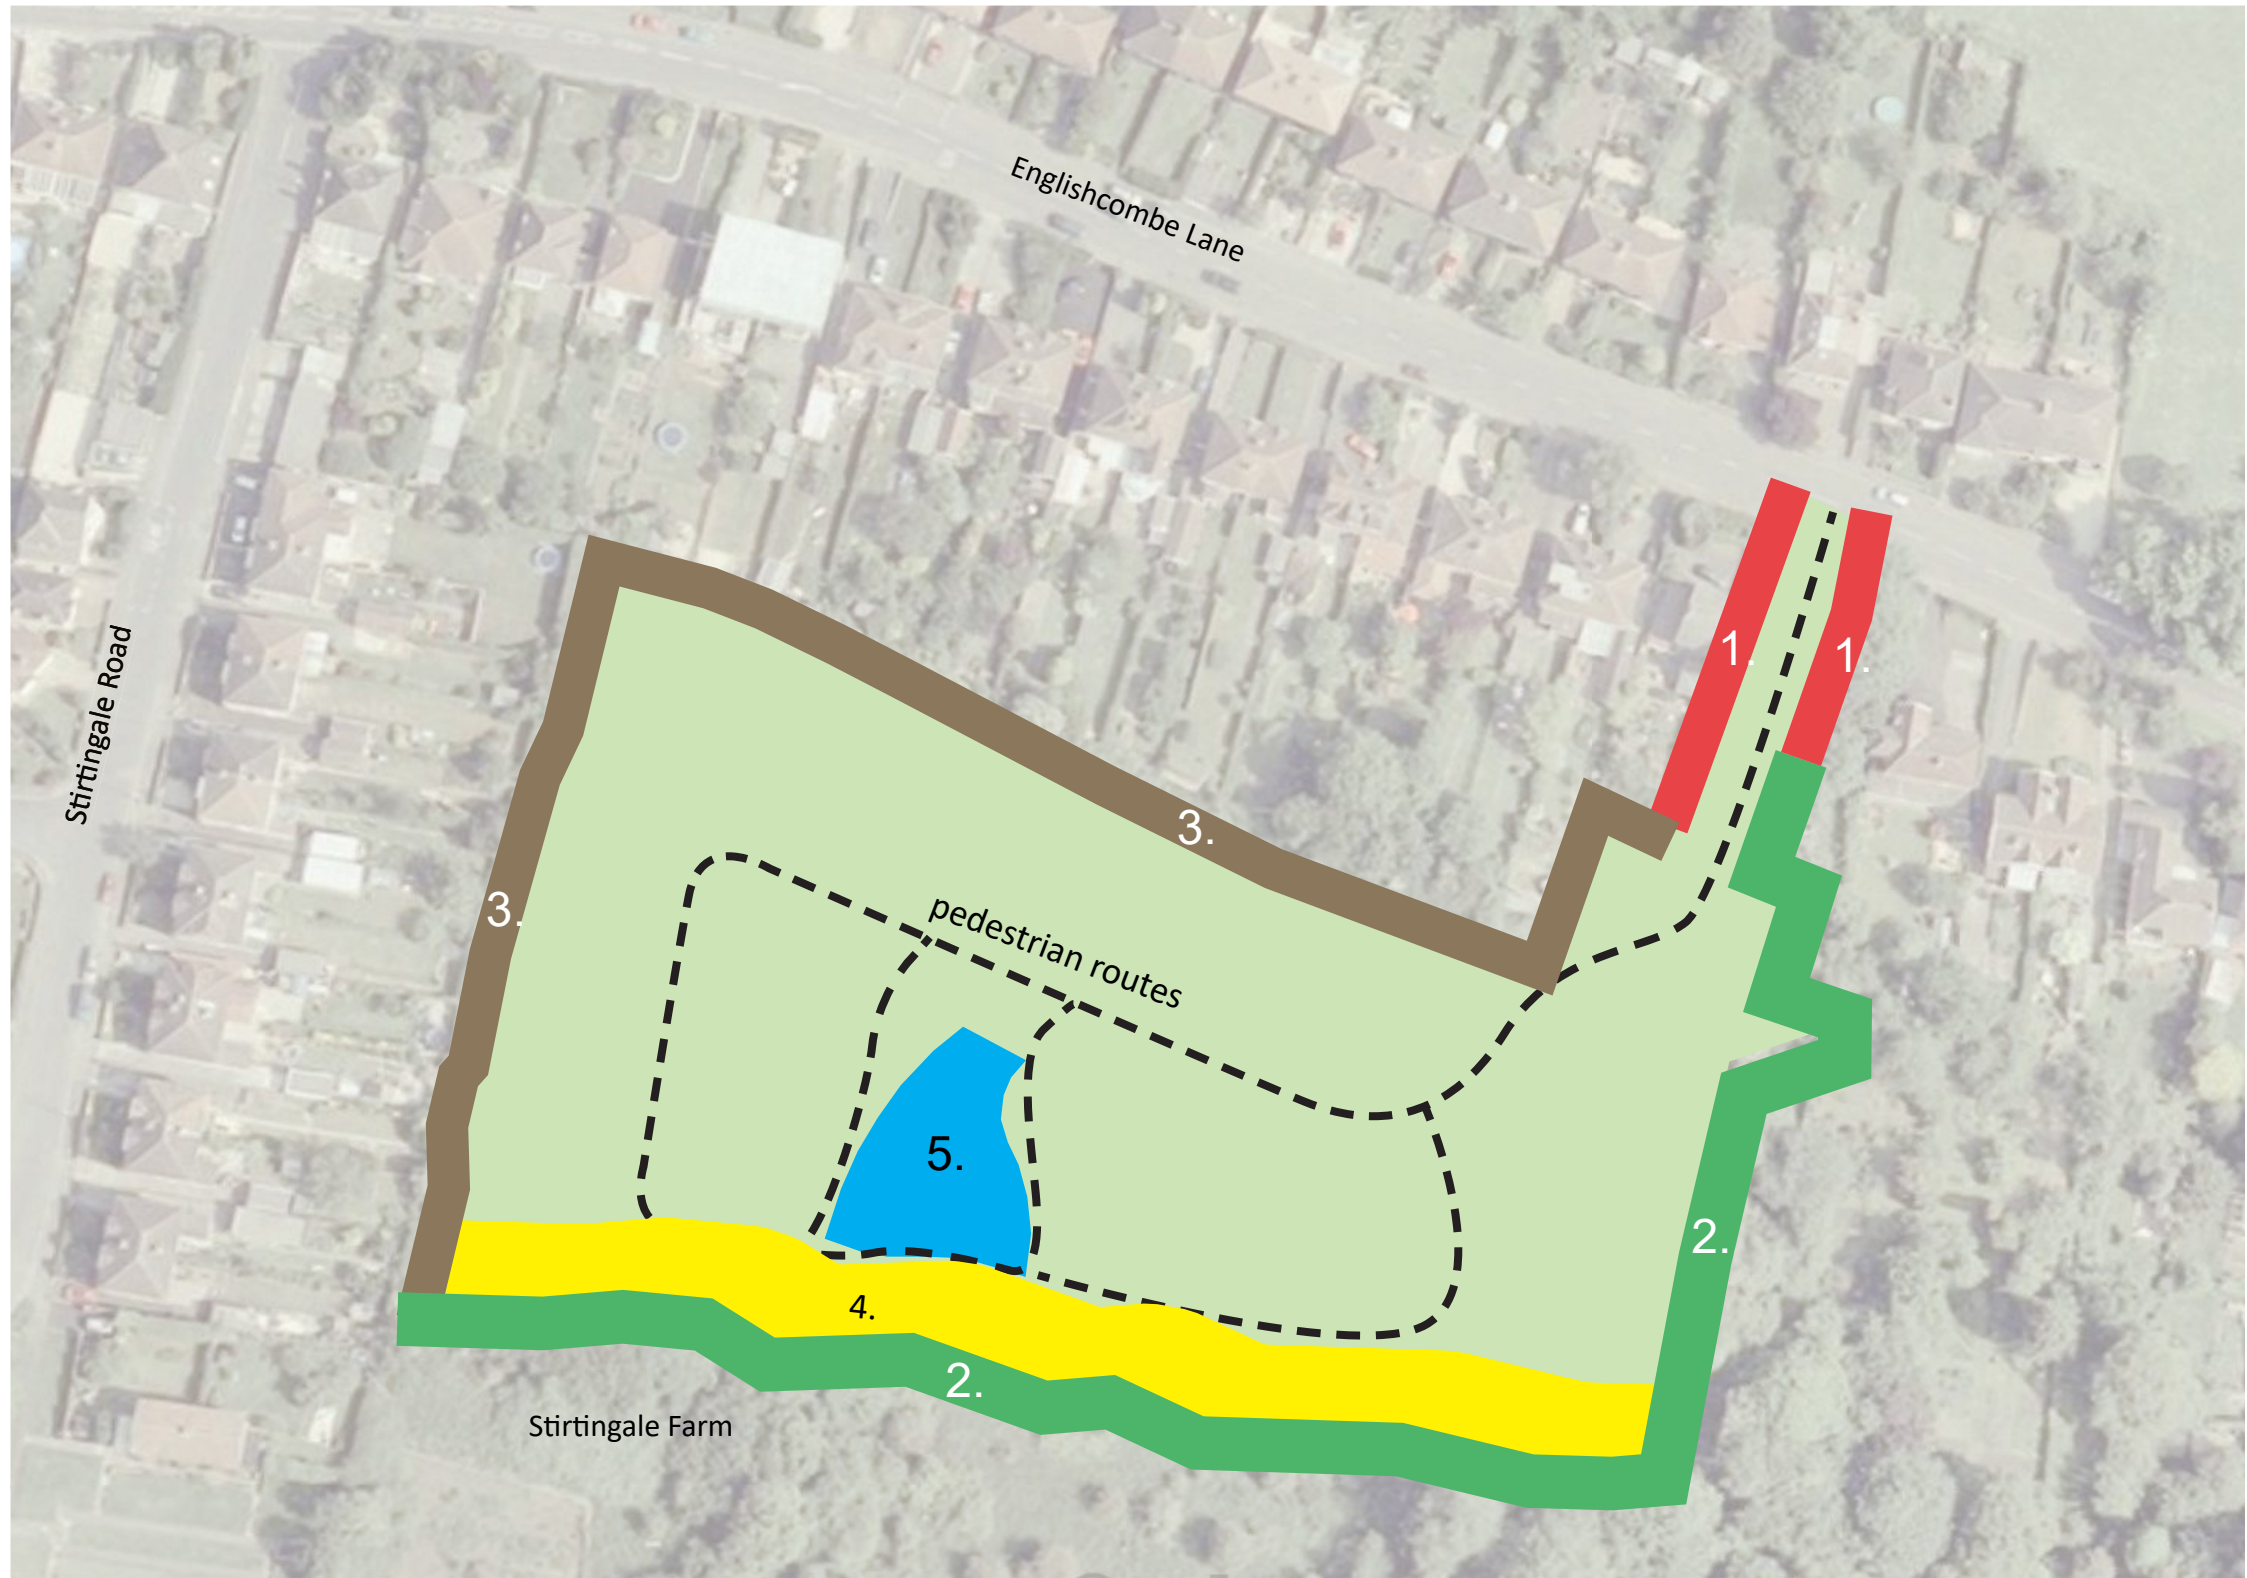
### BOUNDARIES

1. Replacement tree planting and hedge planting and a new wall to define the existing property boundaries. New trees to be a mix of deciduous and evergreen trees with smaller deciduous trees closer to the existing residents.

2. Existing trees and vegetation to the eastern and southern boundaries to be retained.

3. Proposed feather board fencing between the site and existing residents properties.

4. The ecology buffer is a 10m wide no-build zone, extending from the site boundary. This area is intended to be left to naturally regenerate, minimising the disturbance to Stirringale Farm Ecology Area.

5. The existing naturally occurring spring-water (Tufa) habitat area is to be retained and it's associated plants. This area has been designed to offer a place for people to walk and sit and view the natural spring and wider views across Bath.

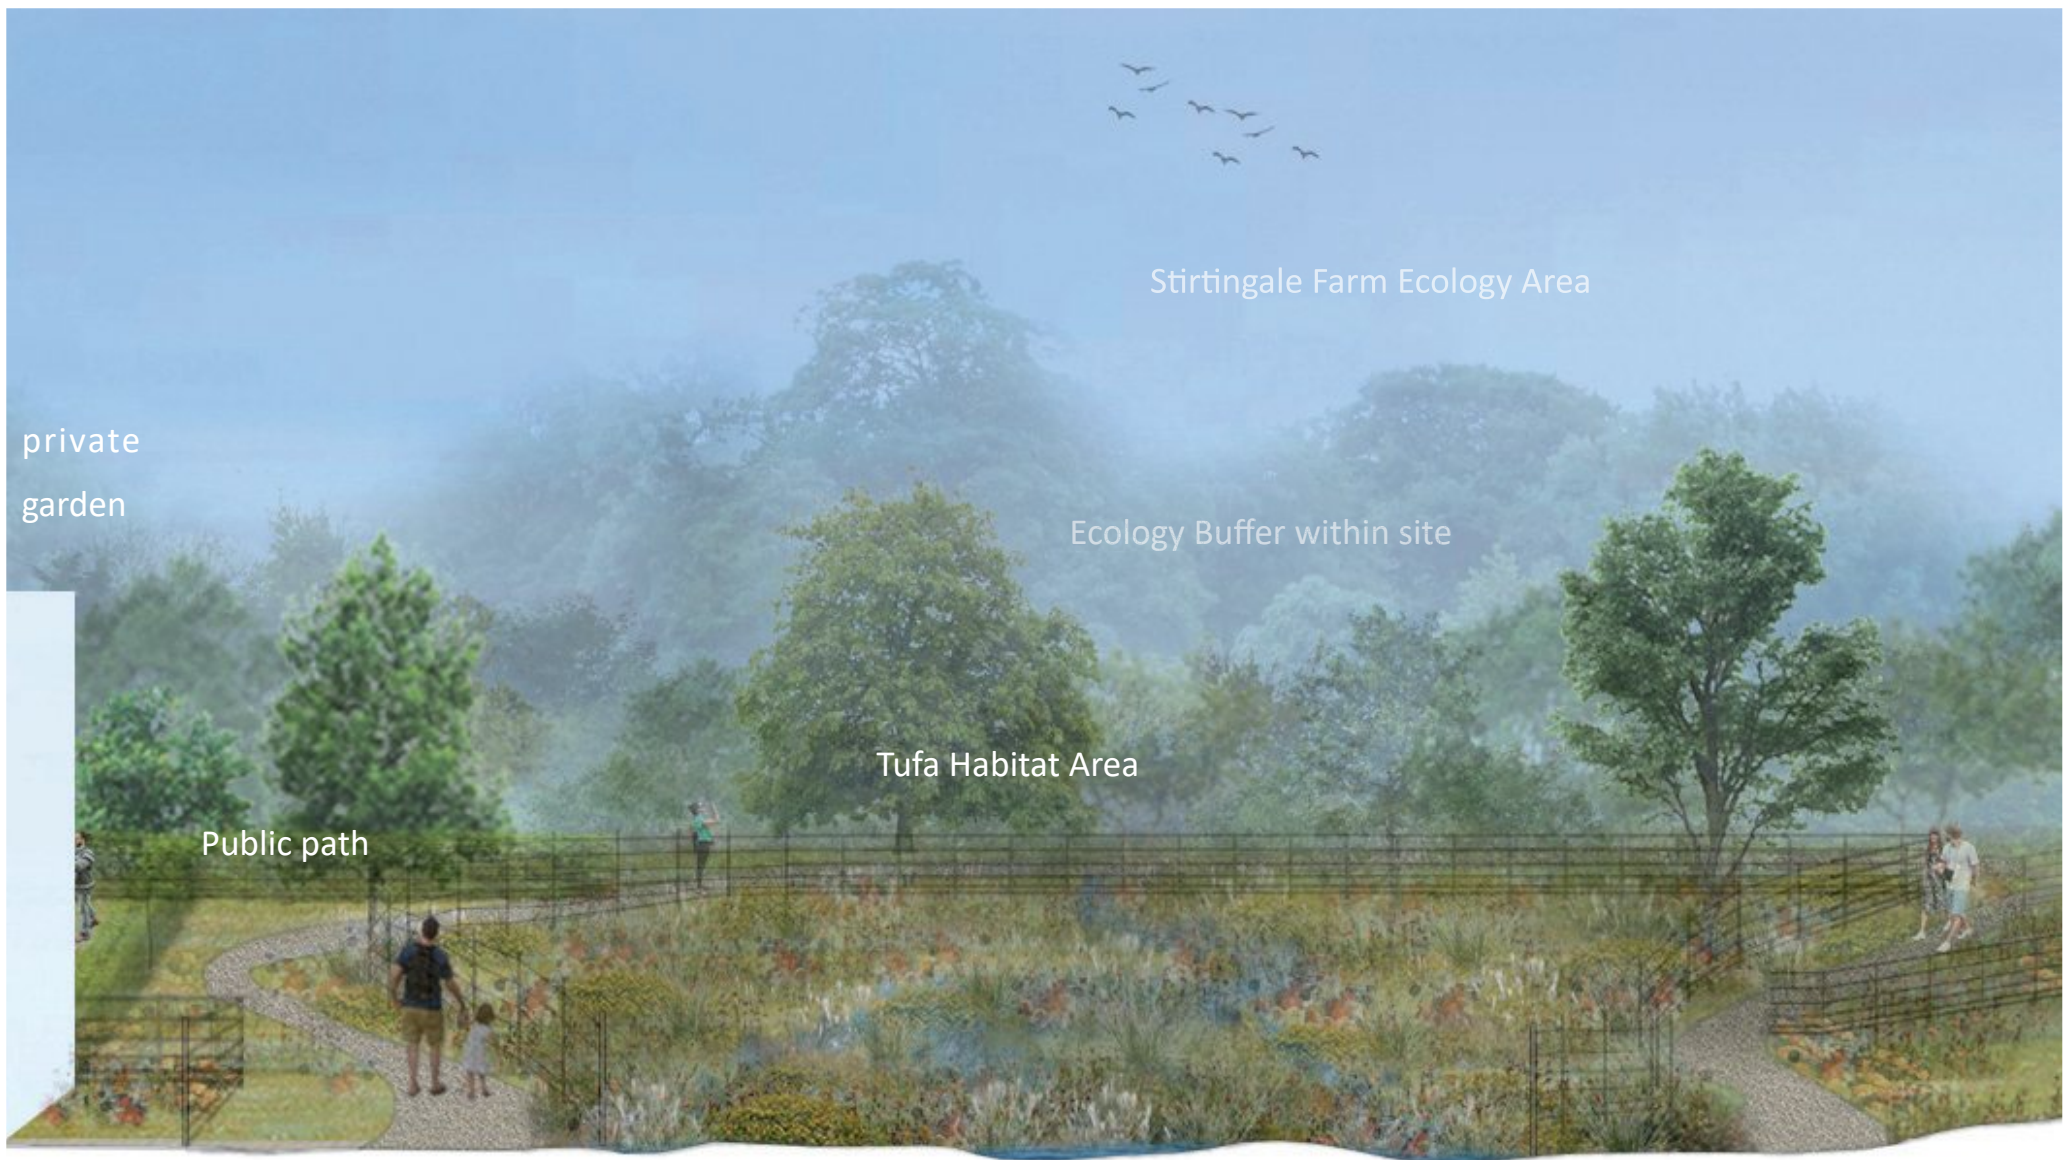
VISUALISATION OF THE TUFA AREA

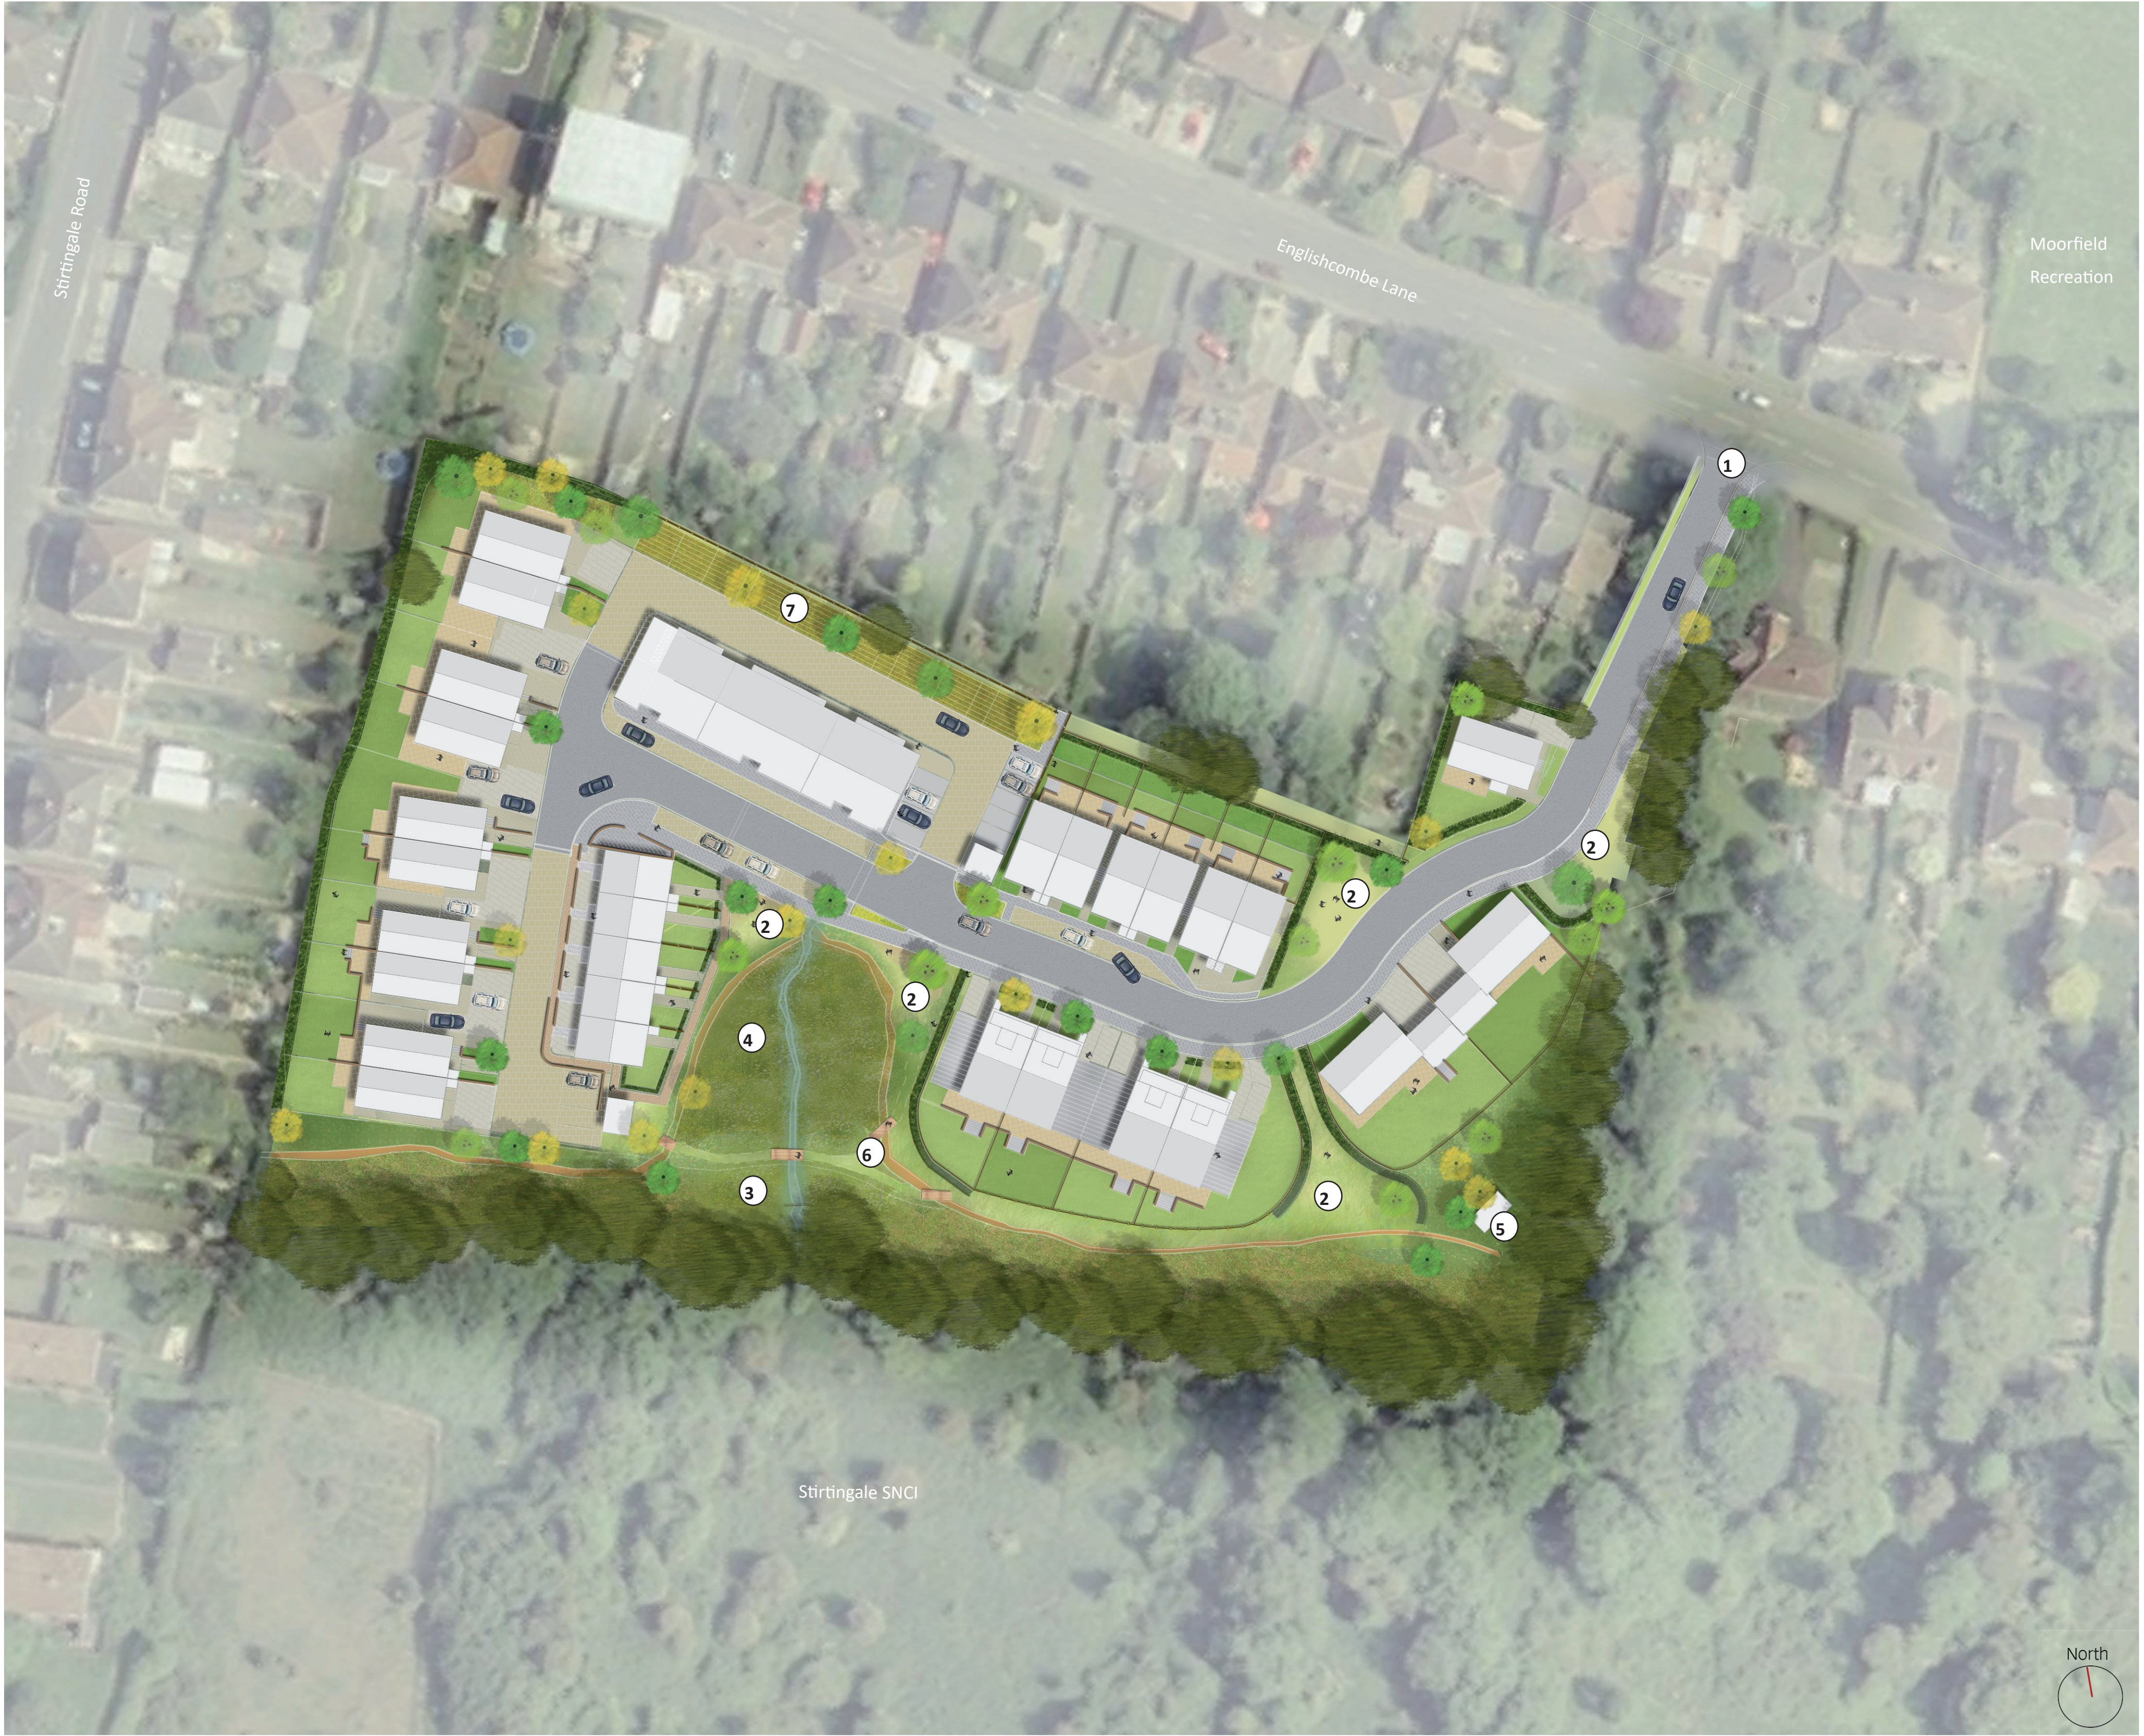
| | Existing trees | ① | Entrance to new development |
| | Proposed trees | ② | Communal areas with planting and seating |
| | Amenity grass | ③ | Southern ecology buffer |
| | Meadow grass | ④ | (Tufa) habitat area |
| | Shrub planting | ⑤ | Bat Shelter |
| | Native hedgerow | ⑥ | Path and foot bridges around (Tufa) habitat area |
| | | ⑦ | Carports with ecology roof |

ILLUSTRATIVE PLAN
